**Office of Oversight
Environment, Safety and Health**

*Phase I
Independent Investigation
of the*

Paducah Gaseous Diffusion Plant

October 1999

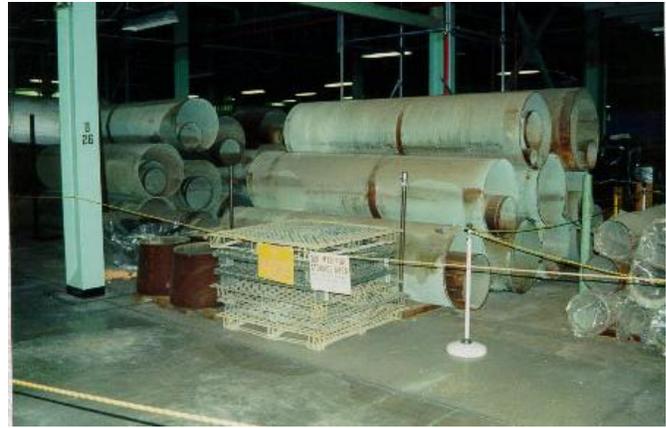
DOE Material Storage Area

- Criticality safety hazards in DOE material storage areas (DMSAs) have not been characterized, analyzed, and resolved even though they were identified more than two years ago.
- Medical personnel have not been sufficiently involved in evaluating hazards to ensure the effectiveness of medical surveillance programs, particularly those for subcontractors.
- Worker training programs do not ensure familiarity with workplace hazards and have not adequately addressed the presence of transuranics (elements, such as plutonium, that have a higher atomic number than uranium). This shortcoming in training may have exacerbated workers' fear of exposure and contributed to instances of mistrust by workers.

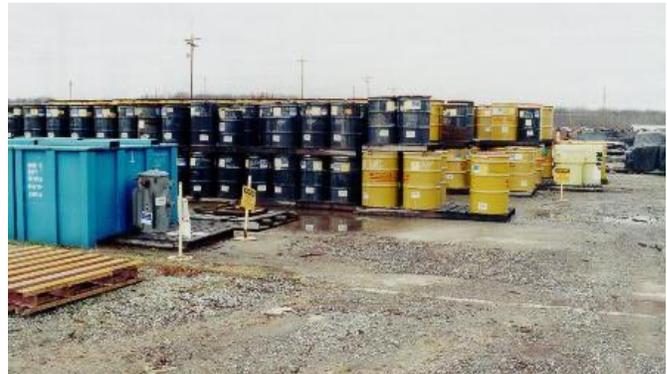
Outdoor drum storage

- A total of 6,444 cubic meters (equivalent to approximately 31,000, 55-gallon drums) of low-level waste are stored onsite at PGDP. This includes 1,775 m³ stored outside in over 8,000 containers that were not designed for long-term storage. Many of the containers stored outside are severely degraded, and some have leaked as a result. Much of the site's low-level waste is not fully characterized for shipment, and some may contain transuranic materials. Disposal of this waste has received low funding priority because there are no regulatory requirements or identified safety concerns requiring near-term disposition. As a result, only 157 m³ have been shipped from the site since 1990. The schedule for completing disposal has subsequently changed from fiscal year 2006 to fiscal year 2012. Additionally, current funding targets assume that no new waste management facilities will be needed to accomplish the site mission. This assumption does not take into account necessary efforts to open, inspect, and characterize the thousands of low-level and mixed waste drums currently stored onsite. Elsewhere in the DOE complex (Rocky Flats Environmental Technology Site and Nevada Test Site), engineered facilities are used to conduct these characterization and segregation efforts. Such facilities would significantly reduce the risk to the workers who open the containers for inspection and characterization.

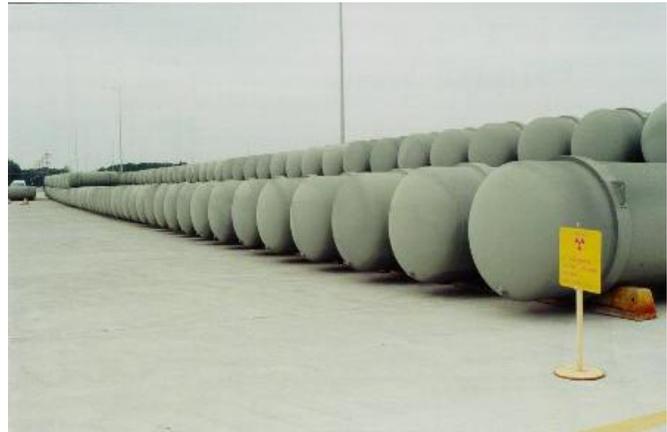
- The nearly 37,000 UF₆ cylinders stored on site in the open at PGDP constitute a radiological exposure hazard and a potential threat to worker and public health in the event of fire and rupture. In 1995, the DNFSB recommended upgrading the condition of the cylinders and converting the UF₆ to a more stable form. Plans to paint 1,400 cylinders (to seal them) were cancelled due to funding constraints, and funds for a UF₆ conversion facility have not yet been appropriated.

Approximately 37,000 cylinders of UF₆, each containing up to 14 tons, remain stored on site pending conversion to more stable forms.

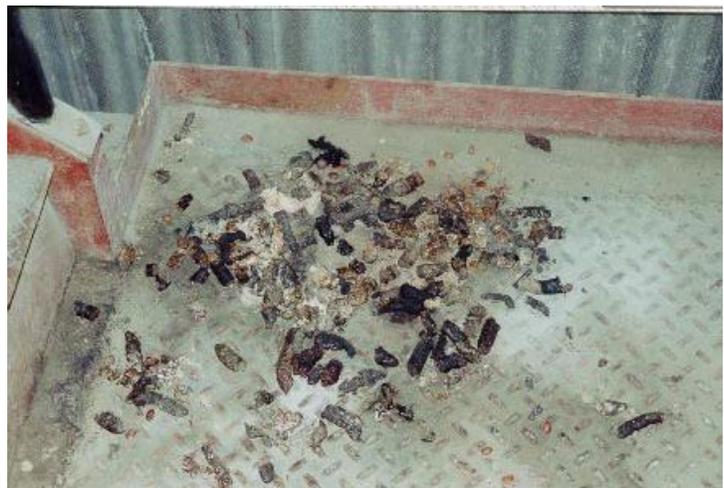
Animal material in Building 340 poses potential health effects to workers.

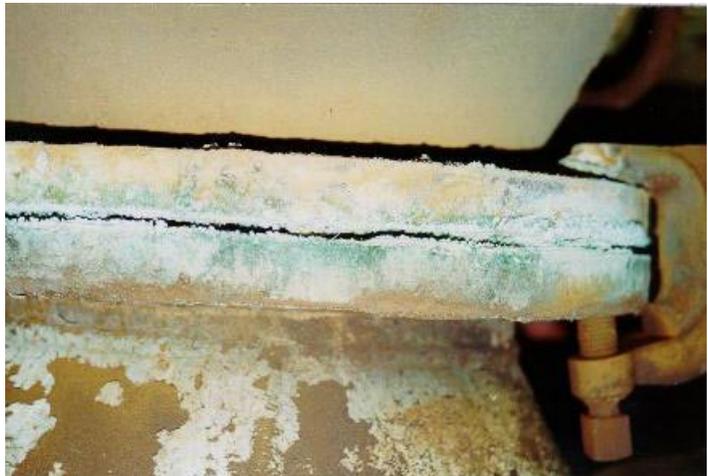
Building 410 corroded ash receiver
