**Office of Oversight
Environment, Safety and Health**

*Phase II
Independent Investigation
of the*

Paducah Gaseous Diffusion Plant

*Environment, Safety, and Health Practices
1952-1990*

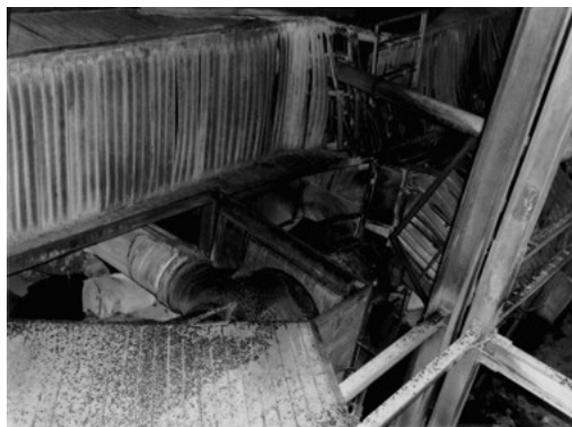
C-337 Fire and Explosion - December 1962

Other significant Plant events included a major fire in Building C-310 in 1956, overexposure of two maintenance mechanics to beta radiation, and an explosion and fire in C-315 in 1978. Major releases affecting groundwater included a spill of 17,000 gallons of diesel oil migrating as far as 2 miles from the site boundary via surface water and the identification of

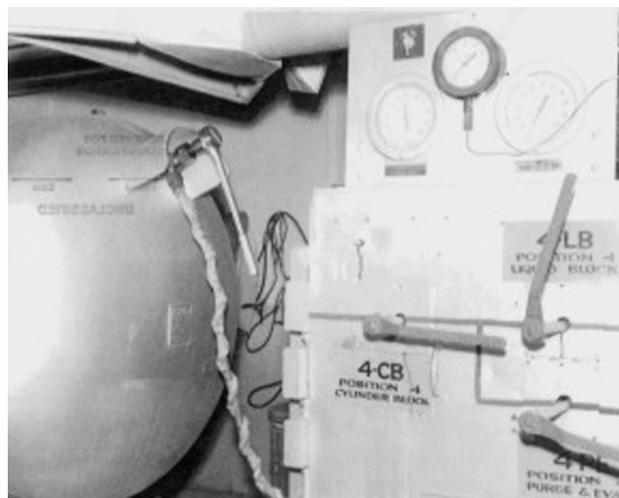
Cylinder Filling Operation

safety features. In November 1960, a cylinder was valved into the cascade before the water bath was fully heated, resulting in backflow into the cylinder from the cascade and an overflow condition. When the inappropriate valving was discovered, the cylinder isolation valve was closed. As the water bath continued to heat the cylinder, the cylinder overpressurized, rupturing the cylinder and releasing approximately 6,800 pounds of uranium.

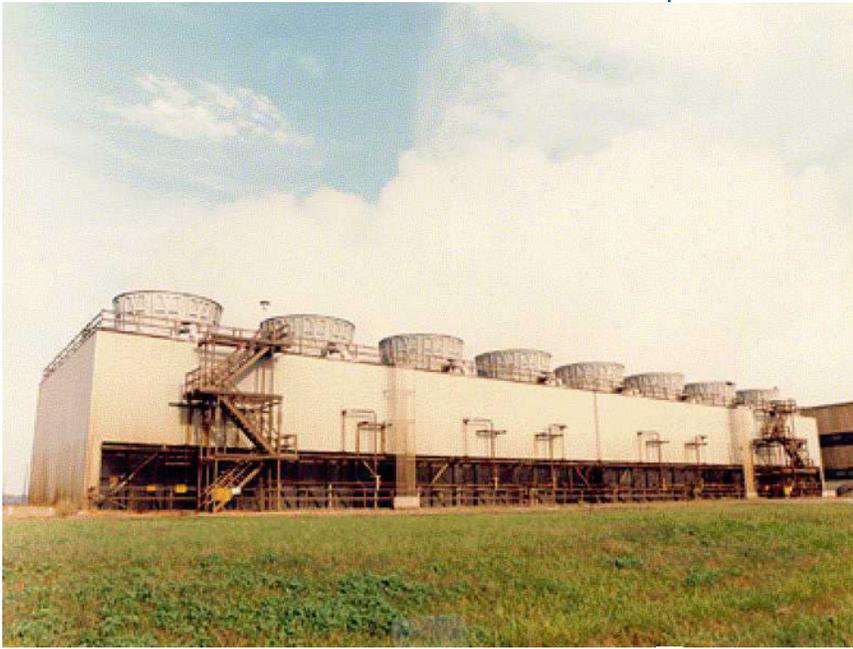
Cooling Towers

During interviews, some former workers expressed concern about their activities on and in the dry cooling towers without respirators or special protective clothing, having previously seen the fungicide spray team in their air-supplied neoprene suits. A 1981 JHA for “Routine Cooling Tower Inspection” does not identify any inhalation or skin absorption hazards for cooling tower repairs, but does require that gloves be worn to avoid splinters. The 1987 version of this JHA requires, in addition, the use of a respirator with a GMC-H cartridge due to the possible presence of legionnaire’s disease bacteria or asbestos fibers, the latter more likely in older cooling towers where the asbestos fibers have become friable. In neither JHA is there any mention of residual

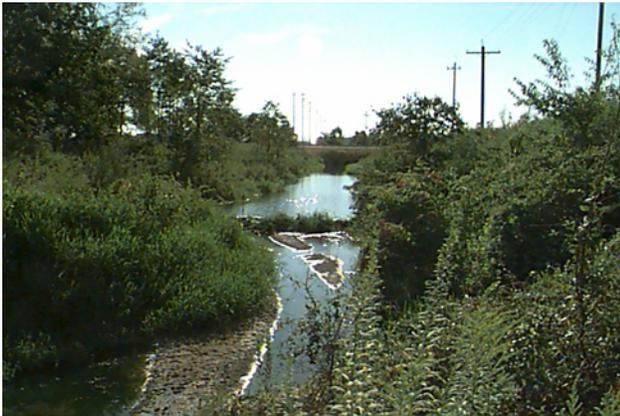
Process and Stormwater Flow Near Outfall K001 - 1999

The most significant liquid radiological effluent source was the C-400 decontamination building. This building contained a variety of systems and processes for isotopic recovery and decontamination of process equipment and scrap metal, as well as the sitewide laundry. Given the nature of operations in this facility, managing the various types and quantities of liquid wastes generated was a significant challenge. These

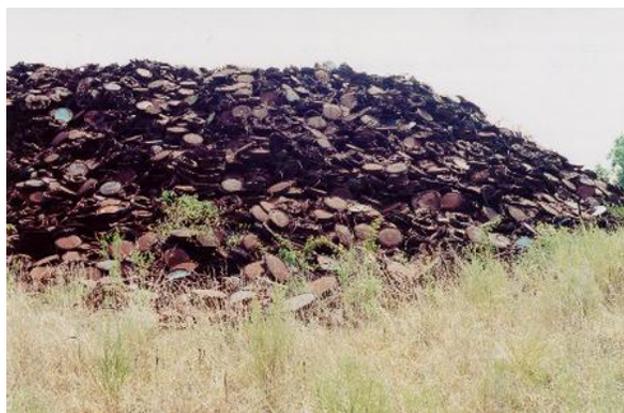
The outdoor storage and placement of contaminated waste and scrap that began in the late 1950s (e.g., Drum Mountain and scrap yards) has continuously contributed to the spread of contamination through surface water runoff. Contaminants settled in onsite ditches and streams. As a result, in the late 1980s efforts were undertaken to characterize and plan for remedial measures to address these contaminants. Limited removal and access controls were established in the 1990s. The Phase I Oversight investigation provided additional characterization of the contaminants in streams and ditches in the vicinity of the Plant.

Drum Mountain
