**Office of Oversight
Environment, Safety and Health**

*Phase I
Independent Investigation
of the*

Paducah Gaseous Diffusion Plant

October 1999

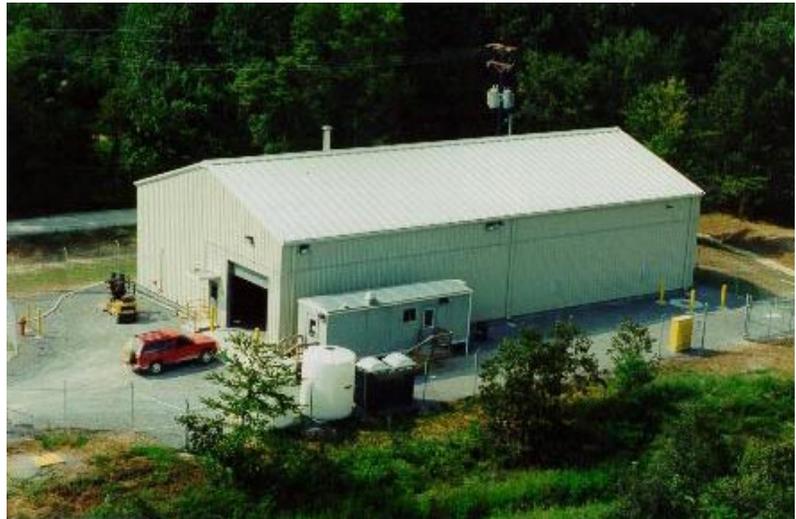
- Sufficient data are lacking on the leading edges of both the Northeast and the Northwest Plumes. The density and positioning of monitoring wells are not adequate to assess the furthest movement or the discharge locations, such as streams, of the two northern plumes. The most recent plume map shows that movement has occurred under a portion of the Tennessee Valley Authority (TVA) property (see Figure 8). Groundwater samples taken by the site in the early 1990s indicated low concentrations of technetium-99 on TVA property. Those sampling efforts were discontinued in the early 1990s. The TVA Shawnee Steam Plant borders the Ohio River.

The pump-and-treat facility for the Northeast Plume was installed to slow the spread of TCE.

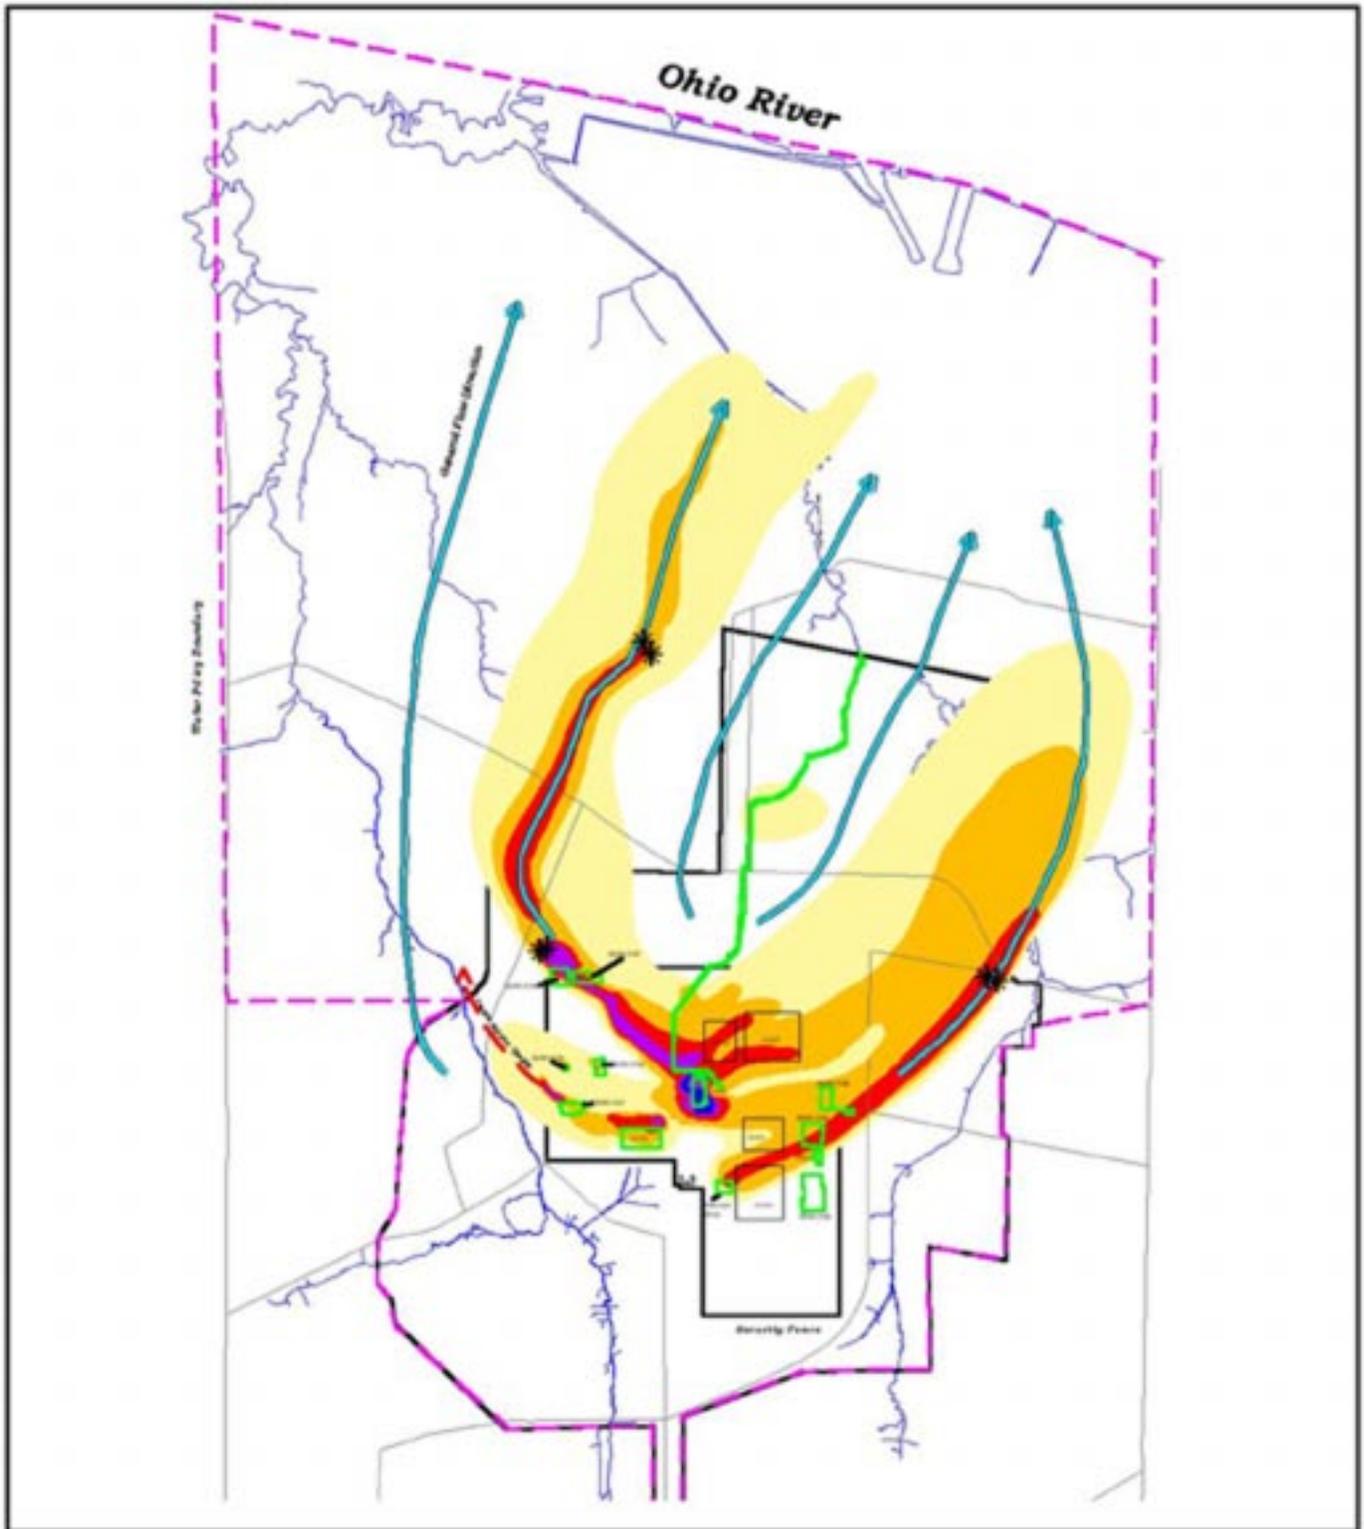
Paducah TCE Contamination in The RGA

- Several sources are responsible for the groundwater contamination in the two major plumes. A major contributor to the Northwest Plume is a facility that used large volumes of TCE for degreasing equipment (Building C-400). High concentrations of TCE dissolved in groundwater near C-400 and characterization studies suggest that TCE exists in pure form in the subsurface. Building C-400 is also a major source of technetium-99 contributing to the

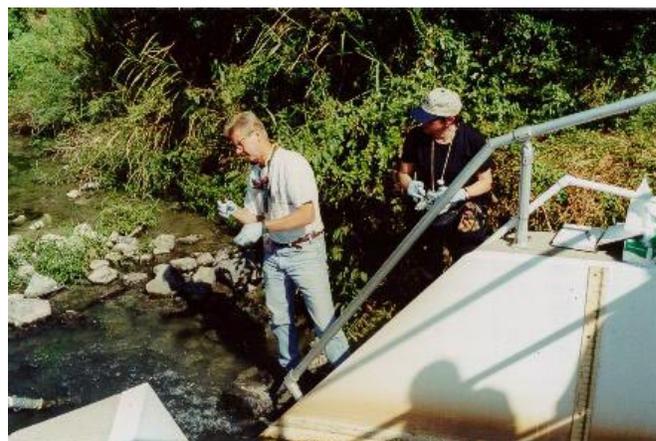
Sampling for volatile organics at K001 Outfall

Radioactivity analyses for surface waters showed relatively low concentrations for all isotopes, with the North-South Diversion Ditch sample showing the highest levels of uranium and technetium-99 at 37 mg/L (12.5 pCi/L) and 26 pCi/L, respectively. Transuranic and thorium isotopes were either not detected or were present in very low concentrations, consistent with prior sampling results conducted by the site. For comparison purposes, one may note that the surface water results are all well below the Derived Concentration Guidelines (DCGs) established by DOE Order 5400.5. The DCGs
