**Office of Oversight
Environment, Safety and Health**

*Phase II
Independent Investigation
of the*

Paducah Gaseous Diffusion Plant

*Environment, Safety, and Health Practices
1952-1990*

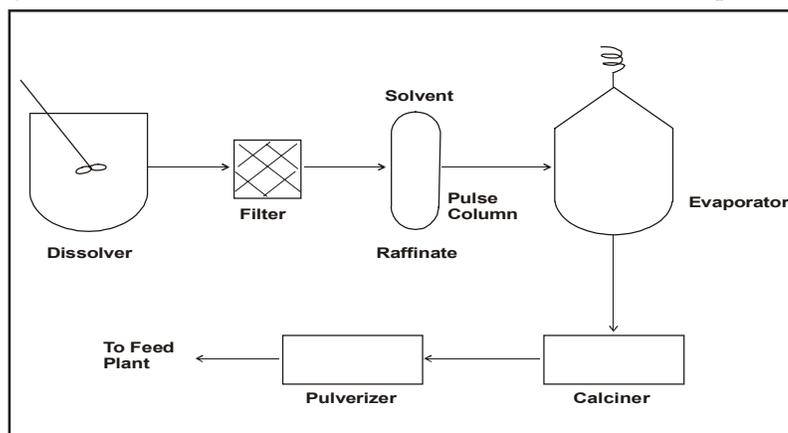
Uranium Recovery Process

The uranium recovery system was not leak-tight, and leaks were common. Operators were instructed to mop spills from process equipment but acknowledged that some spills probably went down the drain. Steps were taken to control operators' exposure to process materials. Routine surveys were conducted to monitor the concentration of radioactivity on surfaces and in the air in C-400, and the health physics staff recommended changes in work practices based on the results of these surveys. Uranium recovery system operators were provided coveralls. Rubber gloves and respirators were available, but their use was not strictly enforced; they were generally worn at the discretion of the operators. The aqueous raffinate from solvent extraction columns that contained neptunium-237, thorium-234, palladium-234, and technetium-99 was discharged to the environment.

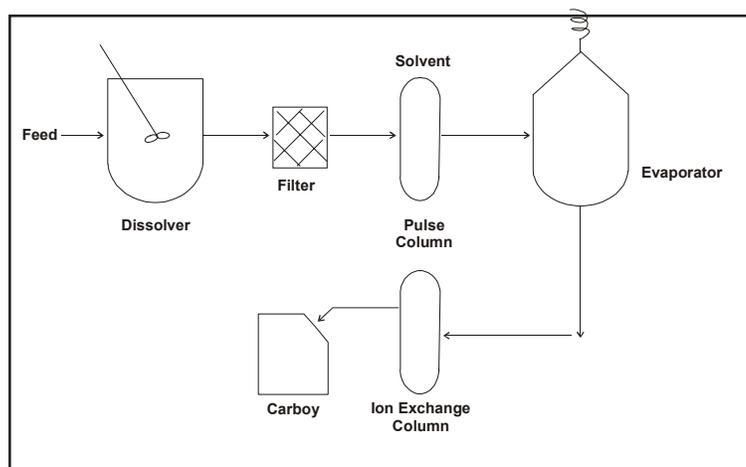
Neptunium Recovery Process

The highest concentrations of neptunium at PGDP were associated with neptunium recovery processes that operated intermittently from 1958 until the late 1970s. These processes separated and concentrated neptunium from receiver ash, cylinder wash water, and MgF_2 pellets used in technetium traps. One liter of neptunium recovery product contained about one curie of radioactivity. Processing systems were complex, leaks were common, and respirators were not always worn.

The limited information available indicates inconsistent implementation of these recommendations. For example, a recovery system operator did not recall using a survey meter. He said that the resin exchange columns were made of glass and that they broke from time to time, discharging their contents to the Building C-400 drain. He was concerned that the system was not sufficiently leak-tight to contain hazardous materials.

recommended. Recommendations included: using non-breakable containers; maintaining tight systems; keeping lids on containers; preventing bubbling, frothing, or spraying of solutions; using rubber gloves; washing the gloves before using them in other areas; using respirators (or assault masks) for welding or burning; and performing alpha surveys of all equipment removed from neptunium processing areas.

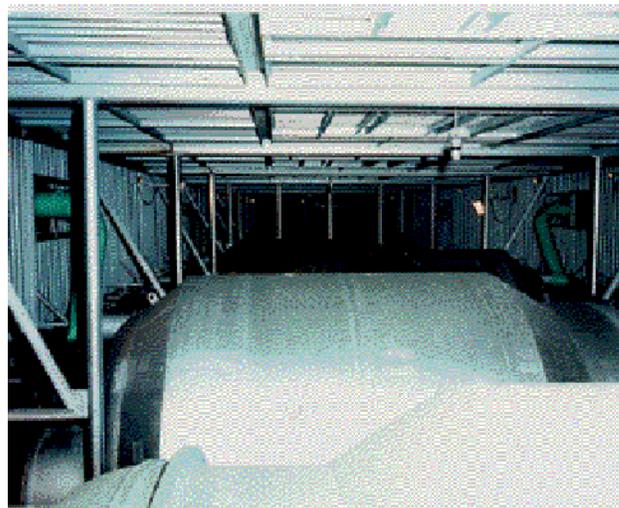
Converters

UF₆ as a gas or solid was sometimes trapped within components and would be released when finally exposed to air. Remaining solids would become airborne, particularly when pneumatic tools were used. Because of the resulting white smoke and pungent odor, these releases were apparent to both the mechanics and the other workers in the area, resulting in some instances of spontaneous evacuation of the area. As one interviewee described it, “smoke out conditions” were commonplace, and workers donned respirators if they couldn’t breathe. The job steps most likely to present these inhalation hazards included removal of the stator/rotor stack from the outer compressor shell, removal of the compressor stub shaft, removal and disassembly of shaft seals, compressor rotor deblading, removal of converter internal hardware in C-409, barrier disassembly in C-400, cutting of the valve purge pigtail, opening or removal of the bonnet flange of a stuck-shut valve, and disassembly of the stem gland of a valve with a leaking bellows. Although respirators were specifically recommended for these activities, their use was sporadic, as reported by those interviewed and by industrial hygiene/health physics personnel who occasionally monitored airborne contaminants and made recommendations for worker protection.

The potential hazards are best illustrated by an early 1970s event recounted by one interviewee. He was involved in removing the top of a 20-inch G-17 valve using air-arcing near the pump shop (at the edge of the C-720 fabrication shop). The valve was tagged, indicating that it had been decontaminated in C-400. However, when the top flange of the valve was lifted with the crane, gray smoke came pouring out and continued to smoke, affecting much of C-720. The crane operator (directly above the valve), who reportedly balked at evacuation because he had seen it happen before, passed out and had to be rescued. Before his evacuation, the interviewee and his supervisor, without any respiratory protection, tried to close the opening by using sledgehammers. Finally, they too had to leave the building without stopping the smoke, due to burning eyes and throats. Three individuals (including the interviewee) exceeded the threshold action levels for uranium on urinalysis. Although the next 24-hour samples were reportedly clear, all urine was collected from the individuals for the next eight weeks. A similar event occurred in C-720 in February 1986, when 100 people were evacuated and 40 were put on urinalysis, with seven on recall. Respirators were not worn for this work, and the JHA did not address the hazards of contaminated valves.

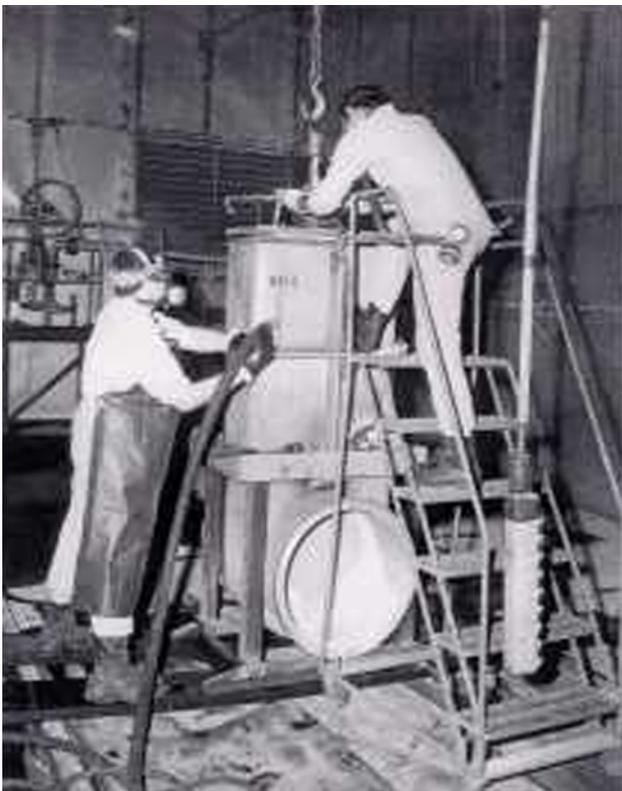
Valve Maintenance

Each UF₆ cylinder is equipped with a manual cylinder valve. Occasionally, these valves were identified as defective and would be replaced. According to procedures that existed in the 1970s, any UF₆ cylinder was required to cool at least five days before its valve was replaced. Cylinders known to be above atmospheric pressure after the minimum cooling period would be cold-burped and further cooled, if necessary, with cold water. If pressure above atmospheric could not be relieved, the cylinder would be turned over to Chemical Operations in C-400 for special handling, which involved dedicated tanks used to further cool the cylinders to promote UF₆ solidification and pressure reduction.

Cylinder valves were normally replaced in C-310, C-315, or the tails storage area. Interviewees also described valve replacement during the 1960s in the vicinity of C-400, after icing down cylinders. One interviewee indicated that until the mid-1970s, defective UF₆ cylinder valves were routinely replaced “on the fly” with the mechanic standing upwind and any escaping smoke going the other way. The applicable maintenance procedure in the 1970s and 1980s required respiratory protection to be worn; however, interviews suggest that although gas masks were available, they were not always
