UNIT NUMBER SWMU 110

UNIT NAME Rubble pile 8

REGULATORY STATUS: AOC

LOCATION: Abandoned constuction road to C-337 (outside fence) N-0300 W-0900 to W-1200

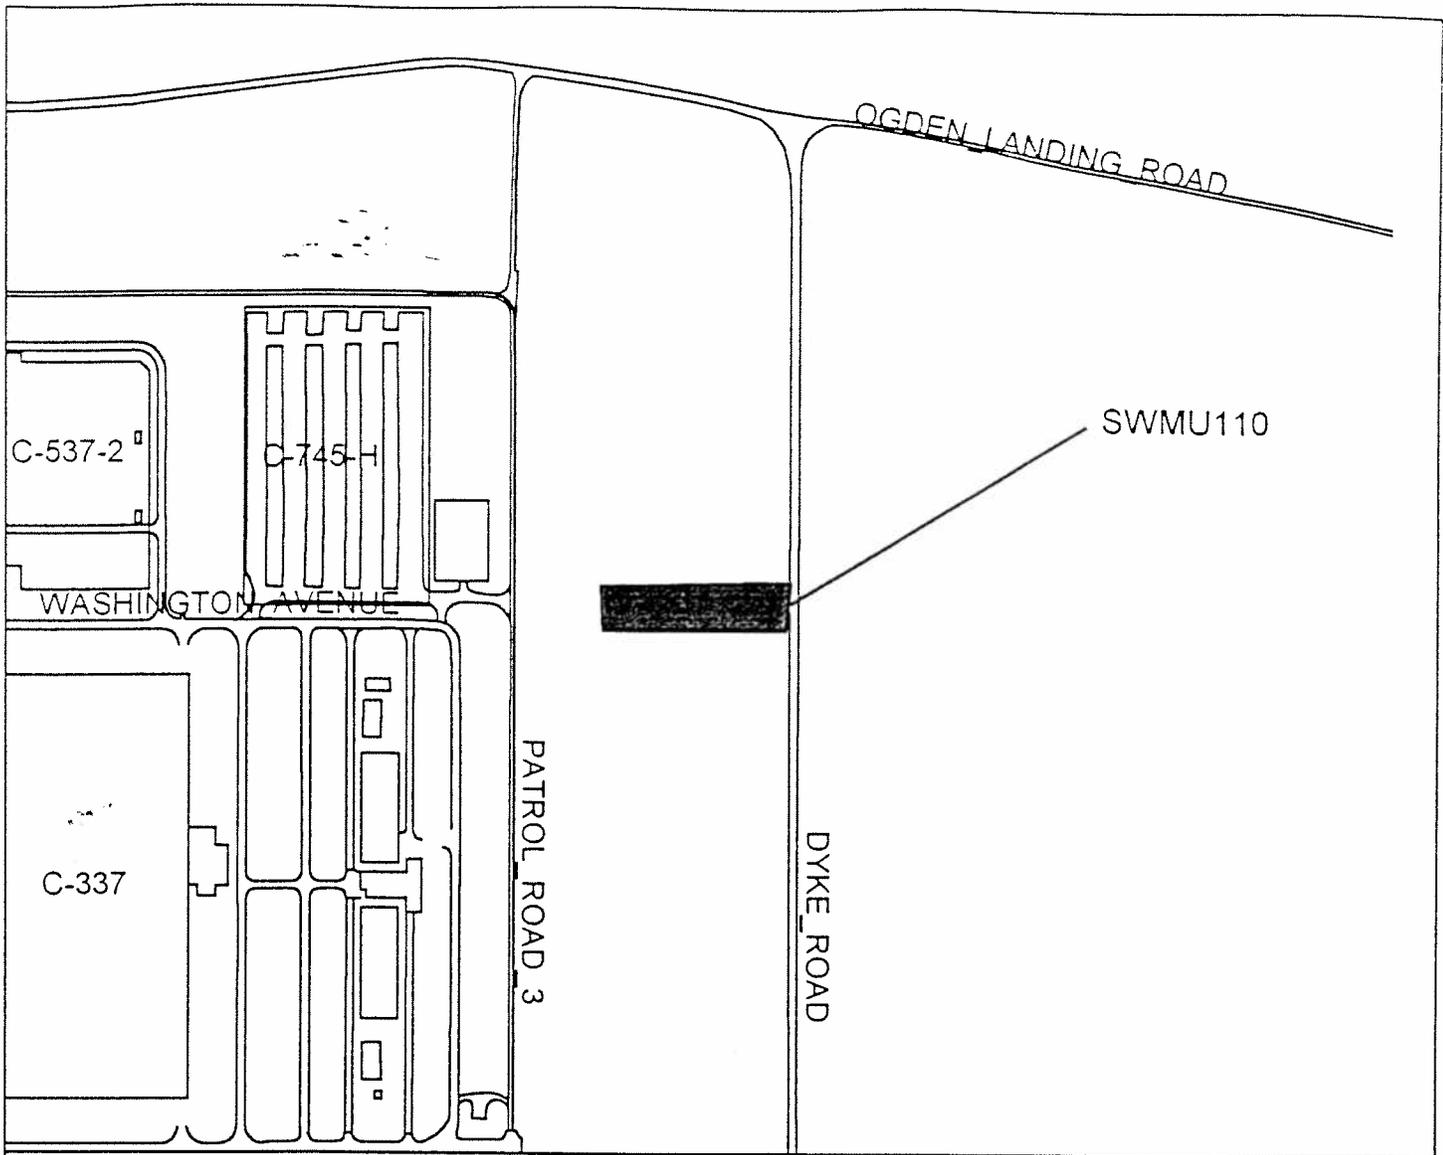
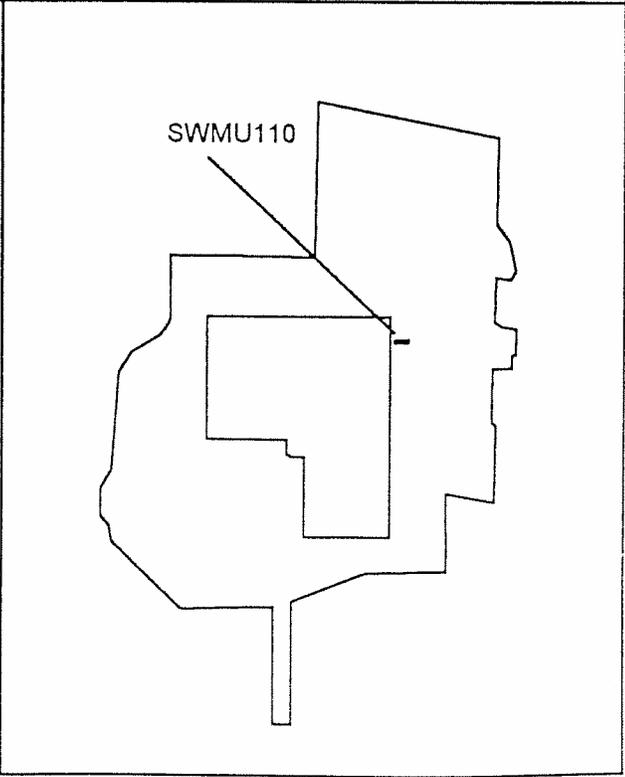
APPROXIMATE DIMENSIONS: Piles of concrete rubble extend about 240 ft approx.
15 ft wide by 3 ft high

SITE/PROCESS DESCRIPTION: The site is an abandoned road. The concrete stored is in piles and dumped on both sides of the roadbed.

DESCRIPTION OF RELEASE: Beta/Gamma scan found contamination primarily in expansion joint tar that is attached to various slabs of concrete. Approximately 150 cpm over background was an average finding on these areas. Found no detectable soil contamination.

RFI NECESSARY: YES
